NUMBER: 08-033-15 REV. A

SB-10058296-1677

Flash: RE2 RE3 RE4 RE6 RE7 RB4 RB5 RB6 RB4 Radio Enhancements

2013-2014	(LD)	Dodge Charger
2013-2014	(LX)	Chrysler 300
2013-2015	(JC)	Dodge Journey

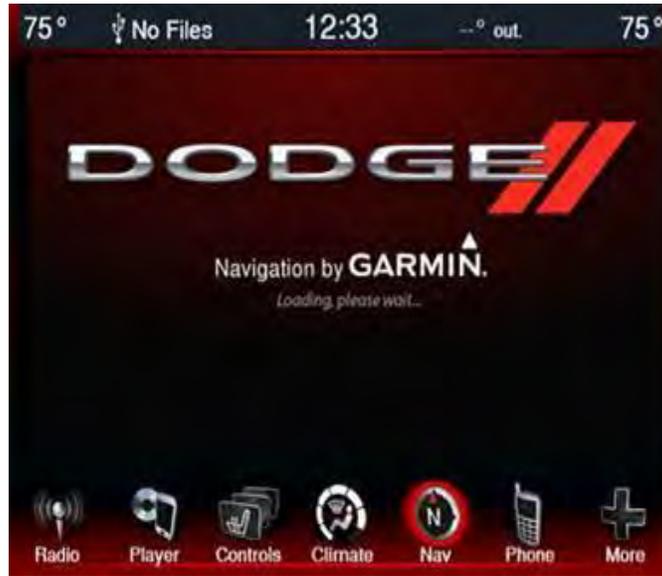
Fig. 1 System Loading Screen

3. Press the navigation screen button and attempt to access the navigation main menu system.
4. Is the radio stuck on the “Loading Please Wait” screen? See ([Fig. 1](#)).

- a. Yes >>> The radio will have to be replaced. Replace the radio using current electronic exchange center stock following normal warranty repair procedures. Refer to published service information in Tech Connect Section 08 - Electrical/8E - Electronic Control Modules/MODULE, Telematics Gateway/Removal. No further action is required, the bulletin is now complete. The replacement radio will contain the latest software update.
- b. No >>> Proceed to [Step #5](#) and perform the software update.
